Article

Monitoring a Pre-Normative Multi-Family Housing Case-Study in a Mediterranean Climate

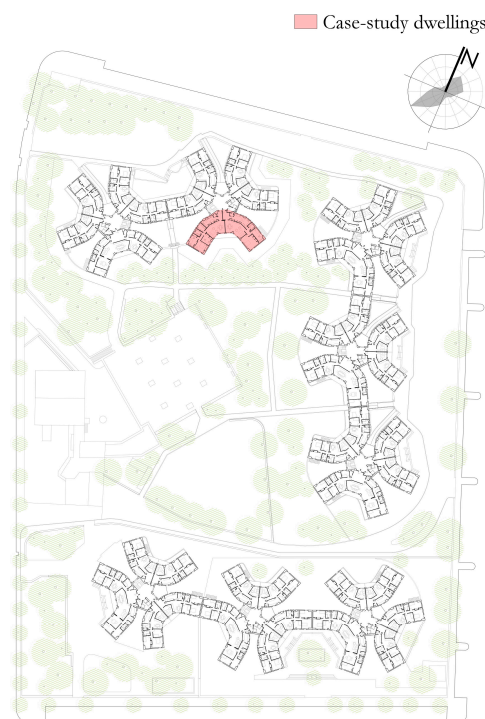
The star-shaped towers reinterpret the “H” block typology (Figure 2): the three wings connected by a vertical communication core offer a wide variety of orientations, while the double corridor eases indoor ventilation. The buildings have an accessible inverted roof and a double-layer brick facade with an intermediate air chamber as its envelope solution, which was an improvement on the widespread 1950s’ constructive solution of single-layer brick walls. However, due to the fact that these buildings were constructed before the NBE-CT-79 mandatory regulation on thermal conditions in buildings, no kind of thermal insulation is present.

Figure 2. Plan of the residential complex with monitored dwellings and prevailing winds.

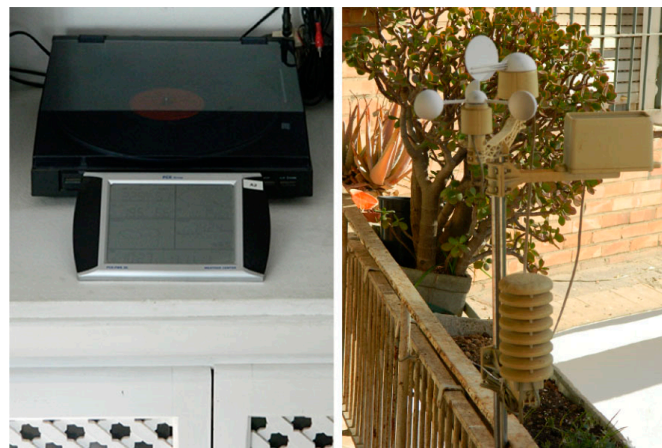
Amongst the different variables registered indoors, air temperature and relative humidity have been recorded by means of two separate sounding lines located in the living-room (day zone) and in the bedroom (night zone) in each dwelling. A weather station located on the outdoor balcony completes the whole system. The weather station is protected from solar radiation and is south oriented (Figure 6) (Table 2). Outdoor air temperature, relative humidity, wind direction and speed are registered with this device.

Figure 6. Indoor data logger and outdoor weather station.

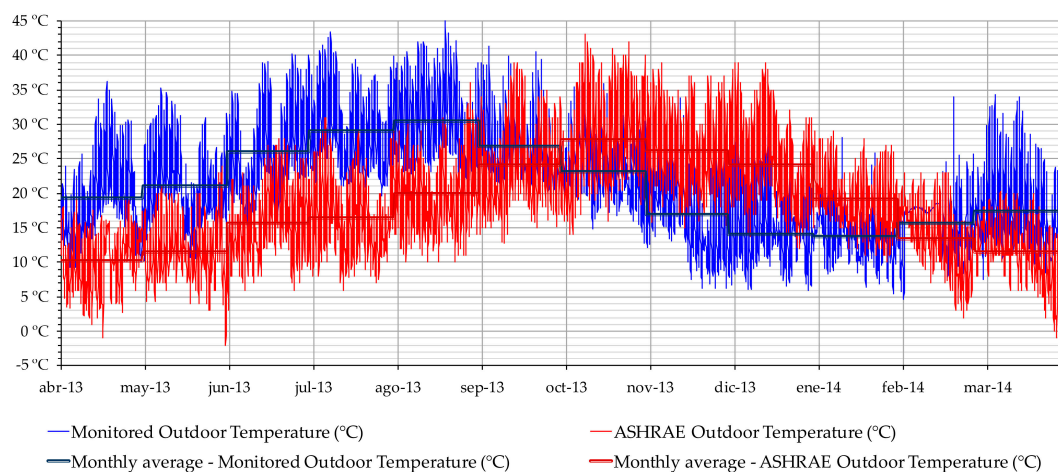
In order to analyze the evolution of the monitored outdoor temperature, weather data from the Spanish Weather for Energy Calculations (SWEC) database [33] are used. Values from a variety of environmental parameters have been gathered on an hourly basis for the past 20 years in the weather station of San Pablo airport, in Seville. The graph shows that average monthly outdoor temperature values recorded in situ are superior to the values from the database in the spring and summer seasons, while these values from the monitoring campaign decrease in autumn, to eventually increase in winter to a higher temperature trend than that of the database values (Figure 8).

**Figure 8.** Monitored and registered daily outdoor temperature and average outdoor temperature.
